State Inventory Number: 92-00419 🛛 New 🖂 Supplemental

| Property Name | | | |
|--|--|--|--|
| A) Historic name: <u>Robert J. and Jean Patterson House</u> | | | |
| A) Street address: <u>526 W. Main Street</u> | | | |

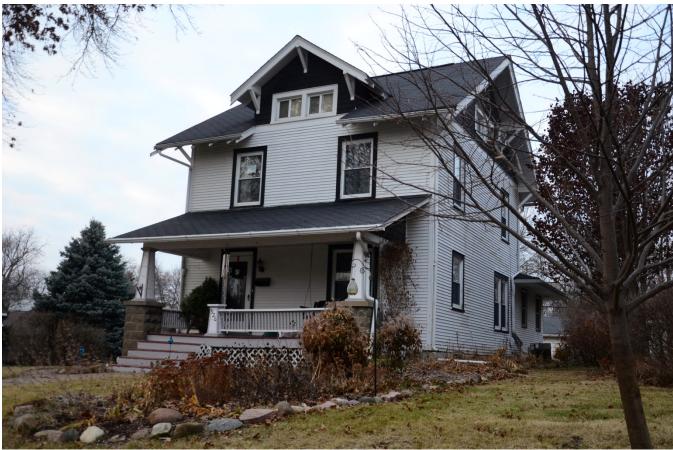
Photograph 92-00419-001 - House, looking northwest (December 2014)

The facade, the south elevation, is divided into two sections with the entry door at the left. There are wood steps leading up to the full front porch. The shed porch roof is supported by tapered wood columns sitting on rusticated concrete block piers located at each end of the porch. The railing and balusters are also wood, and there is a short tapered column supporting the railing next to the steps. The historic entry door is wood with a full length beveled window. There is an aluminum storm door also with a full length window. To the right of the entry door is a wide one-over-one-light double-hung wood window. On the second story, there is a one-over-one-light double-hung wood window above each of the first story openings. A gable-roof dormer rises above the second story in the center of the house, flush with the surface of the main wall. It has a pair of one by one light vinyl sliding windows with vinyl surrounds. The dormer is clad with wood shingles, and it has three wood brackets under the eaves.

The east elevation is divided into two sections. The front/south/left section has a one-over-one-light double-hung wood window with wood surround on each story, with the first story window slightly smaller with a higher sill than typical. On the right/north/rear, there is a pair of one-over-one-light double-hung wood windows with wood surrounds on the first story. On the second story above the pair of windows is a one-over-one-light double-hung wood window with wood surrounds. On the gable, there is a pair of one by one light vinyl sliding windows with vinyl surrounds. The gable has wood shingles and wood triangular brackets.

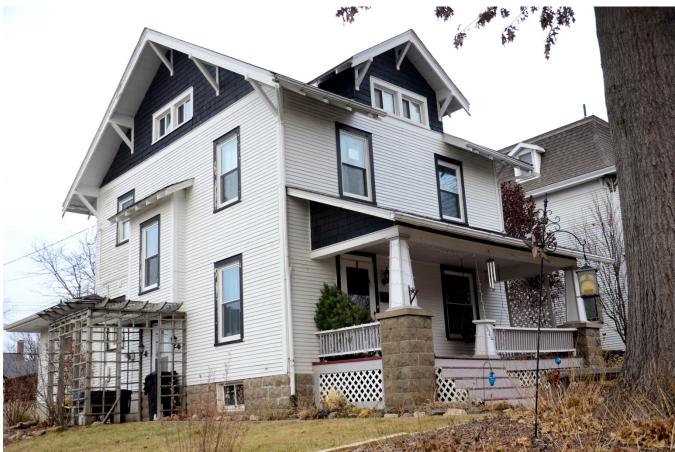
Photograph 92-00419-002 - House, looking northeast (December 2014)

The west elevation, facing Avenue E, is divided into three sections by a centered mid-level square oriel window on interior stairs. The oriel window on as a one-over-one-light double-hung wood window and shed roof with asphalt shingles and exposed rafter tails. Below the oriel is a ground level entry door with an aluminum storm / screen door. Above the oriel window, on the shingled gable, is a pair of one by one light vinyl sliding windows with vinyl surrounds. The section of the house to the right/south of the oriel has a one-over-one-light double-hung wood window on the first story, and a one-over-one-light double-hung wood window on the first story has a slightly smaller one-over-one-light double-hung wood window, there is a matching one-over-one-light double-hung wood window. Above this window, there is a matching one-over-one-light double-hung wood window with wood surround. There are five wood brackets along the roof eaves of the gable. A narrow concrete sidewalk leads from the front porch steps to the side door and continues to a set of concrete steps leading to the side street (no public sidewalk along the side street).

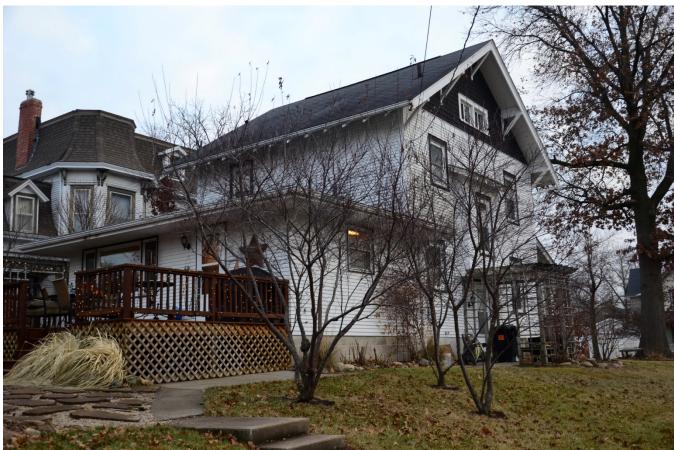
Photograph 92-00419-003 - House, looking southeast (December 2014)

The north elevation, the rear of the house, has a full width one story addition. Sanborn maps show a rear porch, which was not the full width of the house. The assessor lists a c.1950 construction date for the rear addition. The addition sits on a concrete block foundation, and it is clad with wood weatherboard. It has a hip roof is covered in asphalt shingles and has a wide overhang, complementing the original house. The west elevation of the addition has a centered one-over-one-light double-hung wood window smaller than is typical for this house. The north elevation of the addition has an exterior wood deck with wood steps and railing. There is an entry door to the right with an aluminum storm / screen door. To the left is a wide picture window flanked by two single-light narrow windows. The east elevation of the addition has two one-over-one-light double-hung wood windows equally spaced within the wall. These two windows are similar in height to a typical window in this house.

The detached frame two car garage is located at the north side of the lot with access from the alley. The assessor lists a construction date of c.1940 for the garage, but no garage is depicted on this property on the 1943 Sanborn map. It may have been built later in the 1940s or c.1950 with the addition to the house. The garage has two single-car aluminum garage doors, and it is clad with wood siding. The flattened gable roof is covered with asphalt singles and has exposed rafter ends. The north and south elevations each have two windows equally spaced in the wall, which are wood four-light fixed windows.
