Iowa Site Inventory Form State Historic Preservation Office

Property Name	
A) Historic name <u>Matilda and John Marie House</u>	
B) Other names: <u>West side survey map #WS-130</u>	
Location	
A) Street address: <u>727 W Main Street</u>

Matilda and John Marie House	Washington	
Name of Property	County	
727 W. Main Street	Washington	
Address	City

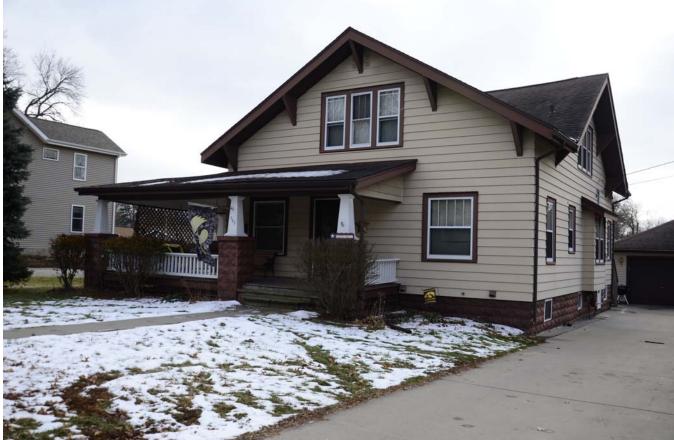
A Craftsman style front porch spans the east two thirds of the facade (north elevation) of the house and wraps around to the east side where it ends several feet south of the northeast corner of the house. The porch has wide wood steps leading up to a wood porch floor, and the railings and square balusters are all wood, as is the vertical grating below the porch floor. The shed roof of the porch is supported short tapered square wood columns sitting on tall rusticated concrete block piers. The historic wood door has a full length vertical beveled window. To the left/east of the entry is a wide one-over-one-light double-hung vinyl window. On the west half of the first story to the right of the entry, there is a wide five-over-one-light double-hung wood window with an aluminum storm / screen. On the second story, there is a set of three three-over-one-light double-hung wood windows with aluminum storm / screens. Along the edge of the roof there are five triangular aluminum clad brackets.

Photograph 92-00790-001 - House, looking southeast (December 2014)

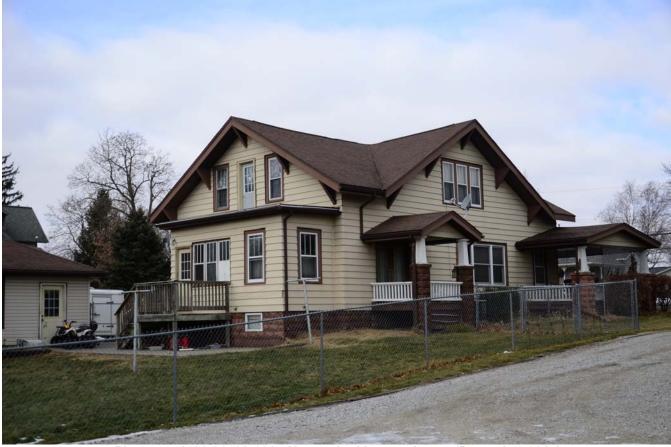
The south elevation, the rear of the house, has three sections, of which the largest is a one story addition covers about three fourths of the first story wall. There are two more sections to the left of the addition. The first section, closest to the driveway on the west side of the house, is a steel entry door with three over three lights in the upper half of the door. To the right of the door is a three over one light double hung wood window with an aluminum storm / screen. The addition sits on a concrete block foundation except at the east end of the addition where the foundation matches the foundation of the rest of the house. There is a small wood deck with wood steps and railing, and on the deck there is a steel entry door located at the left end of the addition, with three over three lights in the upper half of the door. Immediately beside the entry door there is a set of three wood windows having three over one lights. To the right of this set of windows is another three over one light double hung wood window, and below it, in the rusticated concrete block foundation seen here, there is a single fixed light basement window. The east elevation of the addition also has a three over one light double hung wood window. On the second story there is a steel entry door centered under the peak of the gable providing access to the roof of the addition. To the left and to the right of the door there is a three over one light double hung wood window. This south facing gable also has five aluminum clad triangular braces along the edge of the roof

Photograph 92-00790-002 - House, looking northwest (December 2014)

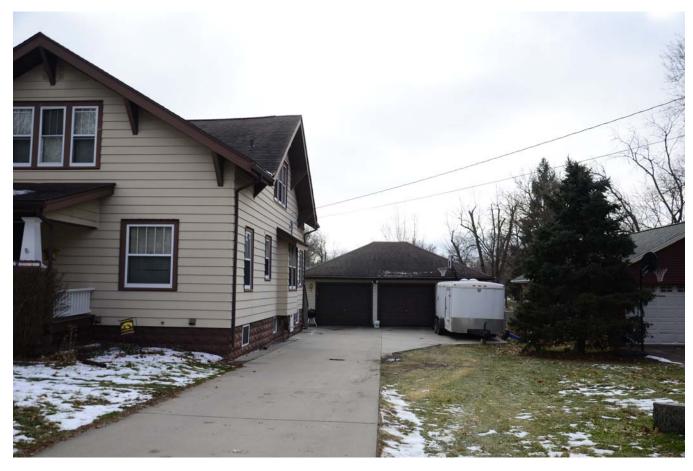
This is a one and a half story frame Craftsman bungalow built around 1920 on the south side of W. Main Street. The house sits on a rusticated concrete block foundation, and it is clad with aluminum siding. The house has wide eaves with brackets, and the cross gable roof is clad in asphalt shingles. There is a small square bay window on the west side of the house. Most windows are wood, a few are vinyl, and all have aluminum surrounds. There is a wide wrap around Craftsman porch on the north and east sides of the house. A two car frame garage sits southwest of the rear of the house, with a concrete driveway providing access from W. Main.

Photograph 92-00790-003 - House, looking south (December 2014)
